Joint Council on Aging Aircraft/
Joint Group on Pollution Prevention

JCAA/JG-PP Lead-Free Solder Project: Vibration Test

Tom Woodrow
Boeing Phantom Works
Seattle, WA

IPC APEX
Anaheim, CA
February 5 - 10, 2006

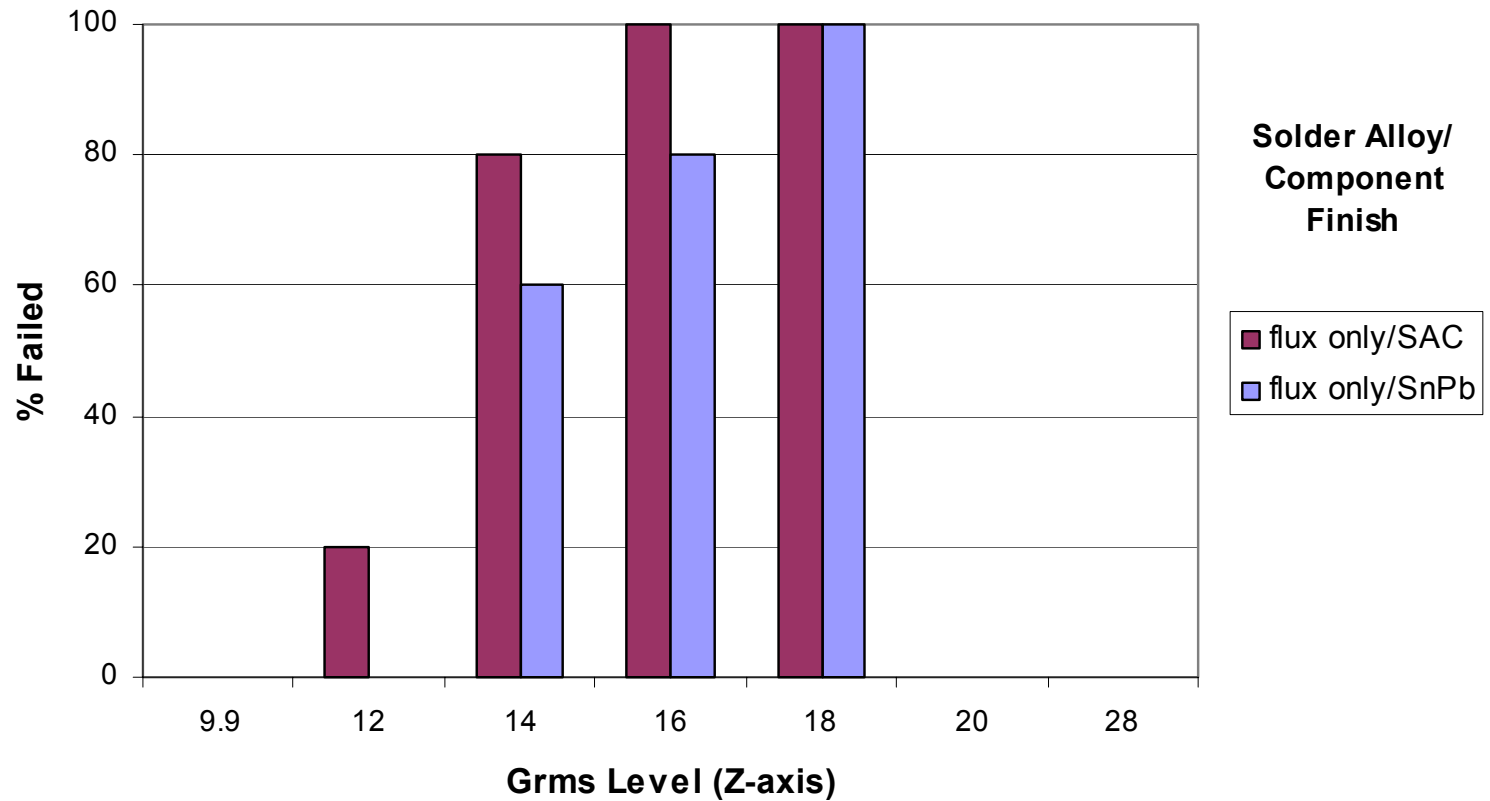
Component Location U18

Component was Reworked

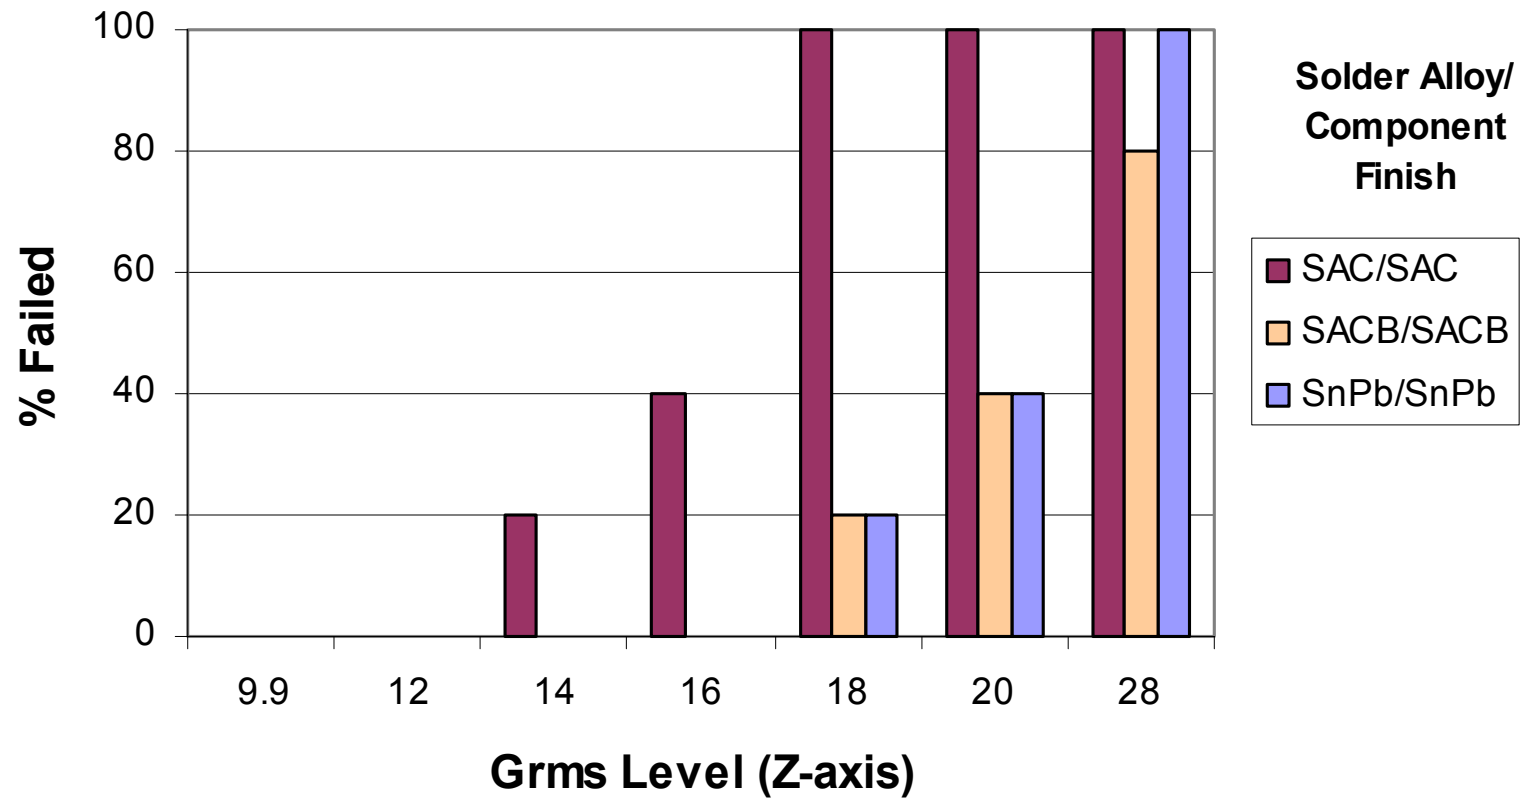
**"Manufactured" Test Vehicles
CLCC-20
Component Location U52**

- SnAgCuBi and SnCu(Ni) generally performed well compared to SnPb. SAC did not.
 - ➔ **CLCC's**: SACB = SnPb > SAC
 - ➔ **PDIP's** (Sn Finish): SnCu(Ni) > SnPb > SAC
 - ➔ **PDIP's** (NiPdAu Finish): SnCu(Ni) > SAC > SnPb
- SnPb outperformed the lead-free solders with:
 - ➔ **BGA's**: SnPb solder/SnPb BGA balls always outperformed lead-free solder/SAC BGA balls.
 - ➔ **BGA's**: SnPb solder/SnPb BGA balls always outperformed SnPb solder/SAC BGA balls and lead-free solder/SnPb BGA balls.
 - ➔ **PLCC's** (Sn Finish): SnPb > SACB > SAC
- With TSOP's, the ranking of the solders changed with TSOP orientation.
